## Debris flows in southeast Brazil: susceptibility assessment for watersheds and vulnerability assessment of buildings

### Abstract

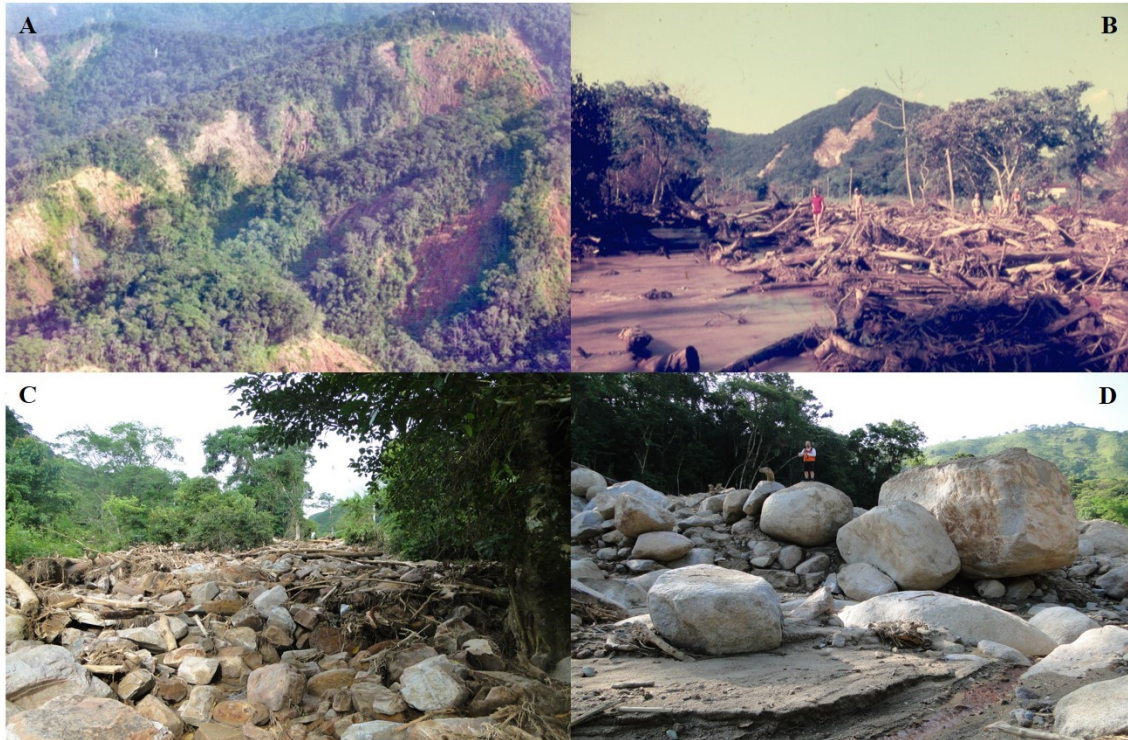
Fig. 2. (A, B) Mass movements in the Serra do Mar, Caraguatatuba, on March 1967 (C, D) and Itaóca municipality on January 2014. Source: Marcelo Gramani; Municipal Archive Caraguatatuba

Approximately 50 years later, on 2014, another city, Itaóca, located in the same orographic feature was affected by cumulative rainfall of 150 mm/6 hours causing deaths with houses destroyed and structural damage to bridges (Fig. 2). In this area we selected three basins more: two basins with records of landslides and debris flows (Palmital 1 and Gurutuba) and a third basin, with similar morphological characteristics, on the other hand, without any record of any landslide or debris flows registered.

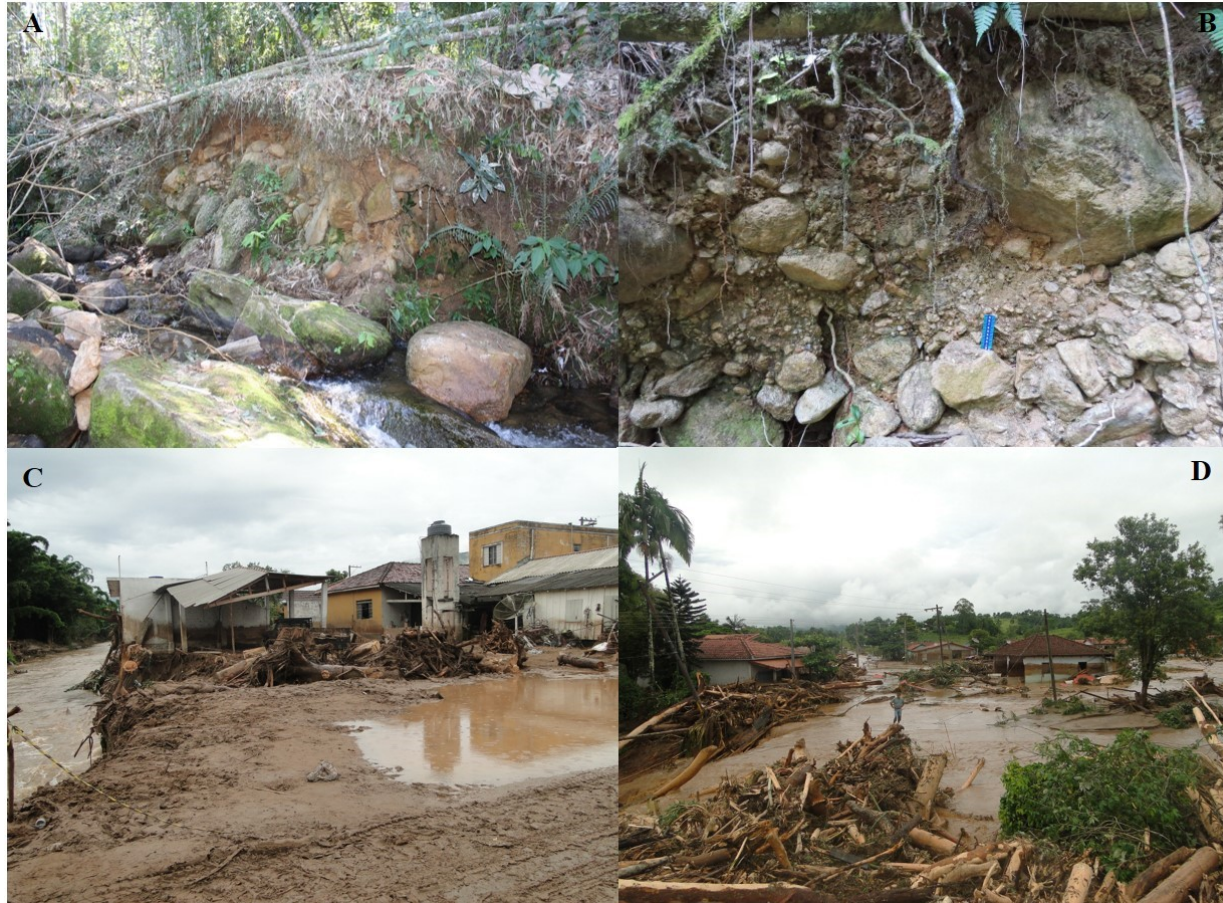
Fig. 3. Deposits in Santo Antônio basin (A), Pau d'alto basin (B), mudflows and flash floods in Itaóca city from 2014. Source: Itaoca municipality.

According to the Circularity Index (Ci), all basins have a more elongated shape (Ci <0.5), except Palmital 1 and Palmital 2, where the large and extra-large rock block deposits were identified, especially the Guaxinduba and Pau d'alho basins (Fig. 3B). According to literature, this elongated shape is more favorable to deflagration of debris flows in steep landscaping slopes (Crozier, 1986). However, two basins (Santo Antonio and Aldeia) presented a circular shape as well large deposits related to previous debris flows (Fig.3A). Although all basins show high values of Relief Ratio (Rr), indicating a significant potential of transport and flows, those with higher volumes of deposits had the lowest values of this index (Santo Antonio, Pau d'alho and Guaxinduba).

The Gurutuba basin (A2) has critical values in all morphometric parameters, where, in its lower portion, the large debris flows with large size deposits were mapped and the high destructive power (Fig. 3) and rapid flash floods that reached elevations between 1.90 and 2.60 m, destroying about 15 buildings.
